CARMEL DAM
(WEST BRANCH RESERVOIR)

PUTNAM COUNTY, NEW YORK
INVENTORY NO. 29

PHASE I INSPECTION REPORT
NATIONAL DAM SAFETY PROGRAM

Date of Inspection: 24 APRIL 1978

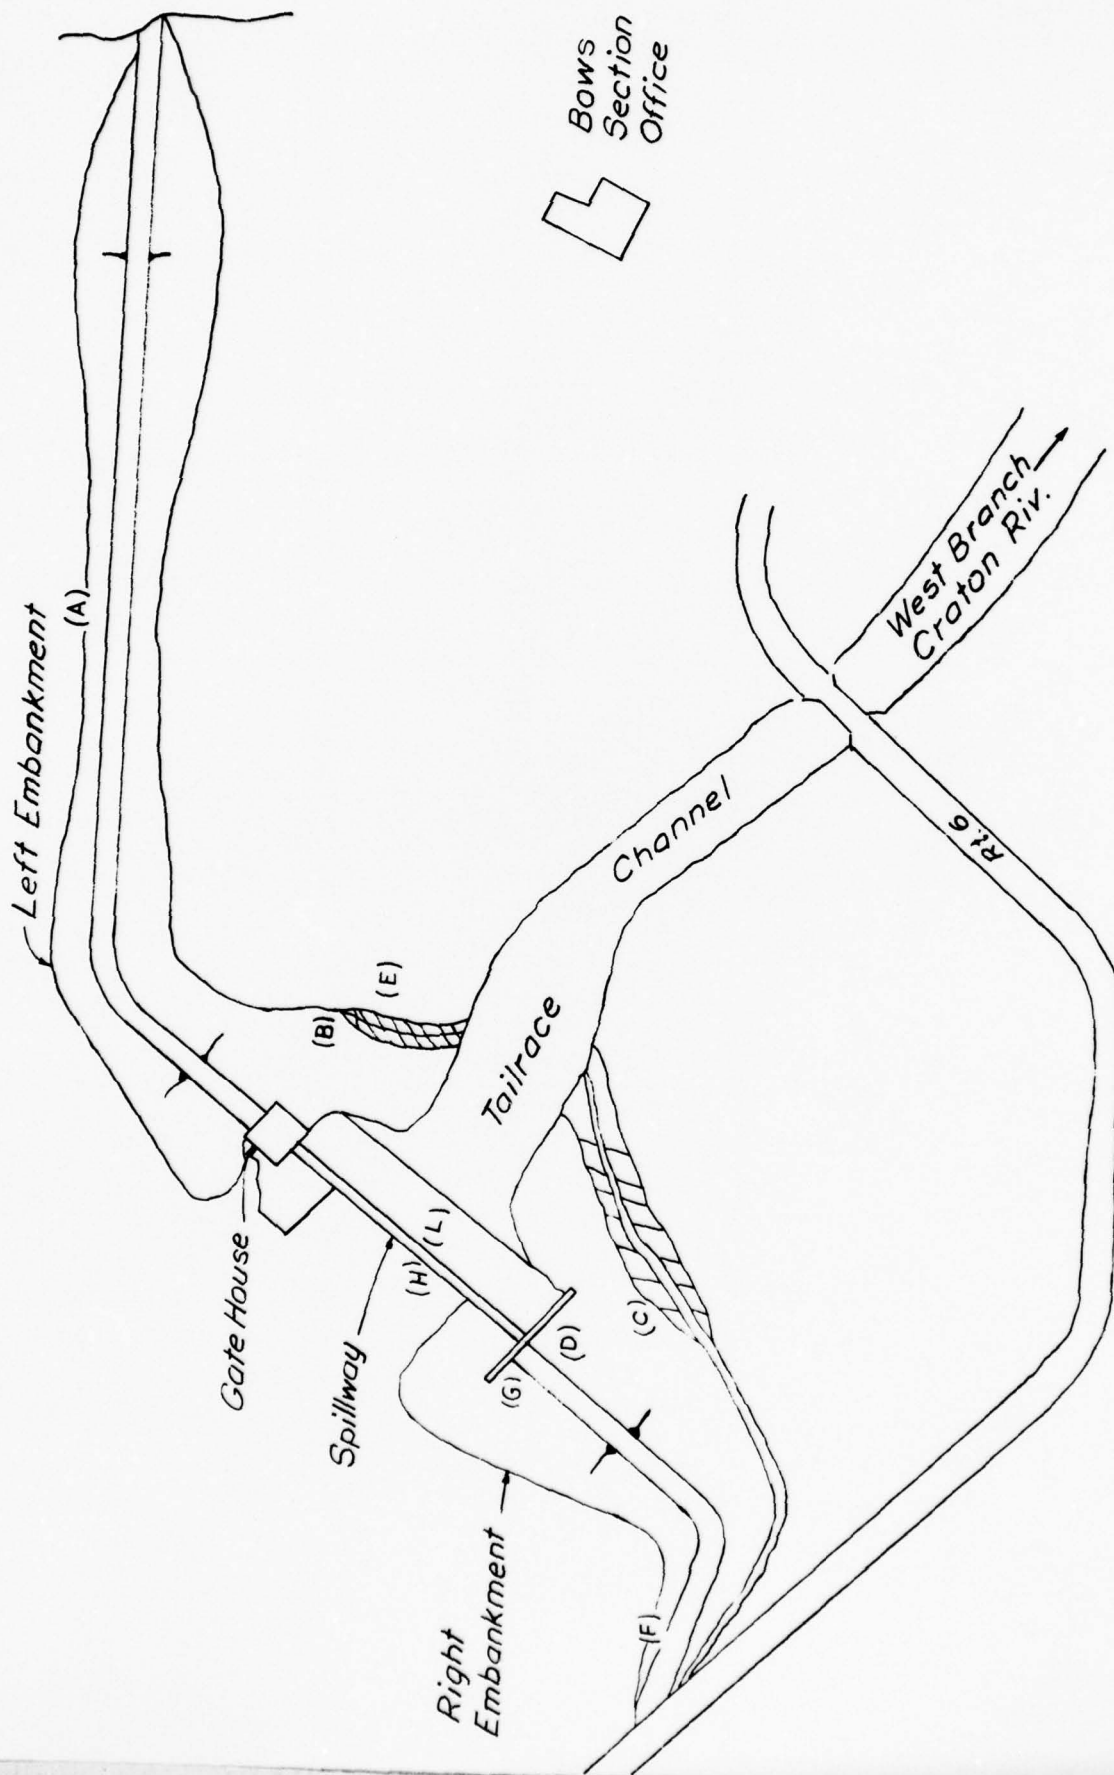
LOCATIONS OF OBSERVATIONS
WEST BRANCH RESERVOIR
MAIN CARMEL DAM
NOT TO SCALE

The letters in parenthesis indicate the locations of observations listed in Chapter 3.1.
